Lake Erie Community Park West Trail Improvements

SUMMARY

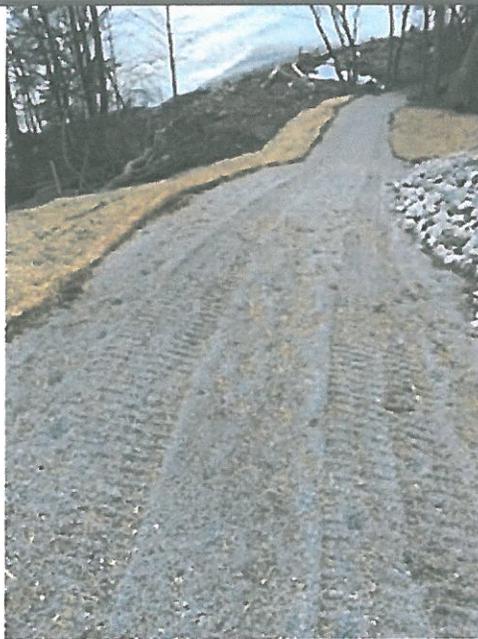
This project was to improve the conditions of a walking trail down to the Lake Erie water's edge within the Lake Erie Community Park on the west side in Girard Township, Lake City, PA. The existing trail was in need of stormwater drainage and grading back of the excessively steep areas of the trail to make safe access to the water for everyone.

The trail was sloped slightly to the inside to allow for stormwater to flow into the subsurface and surface drainage to a catch basin and tubed to the toe of the bluff. This will help avoid erosion on the trail. After the steep portions of the trail were graded back, a GeoWeb contained aggregate system was applied to the trail and filled with two different sizes of limestone for a more stable and comfortable walking surface. The trail was also widened to allow access for emergency personnel in the event of a water rescue.

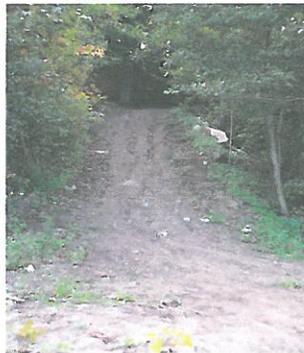
Before

The existing path within Girard Township's Lake Erie Community Park, West Side, was very steep and needed constant maintenance due to there being no stormwater controls. The path would get washed out with each rain event, allowing non-point source pollution and sediments to flow down into Lake Erie. The rain also caused deep erosion areas across the path which were dangerous for anyone utilizing the path. Because this was not an improved trail, there were two very steep, unsafe areas that made traversing the path hazardous. With steep 110' bluffs throughout the Lake Erie Community Park, the rough path was used by visitors, fishermen to access the water's edge, as well as the local emergency personnel when they were called out on water rescues. Making the path into a viable walking trail was imperative to keep everyone safe.

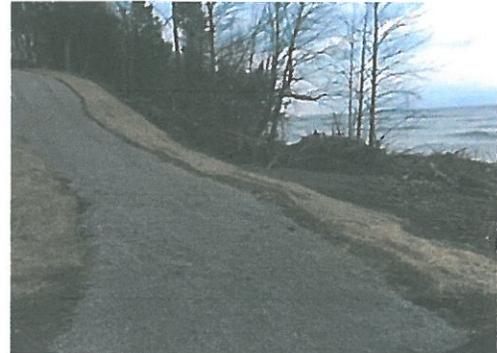
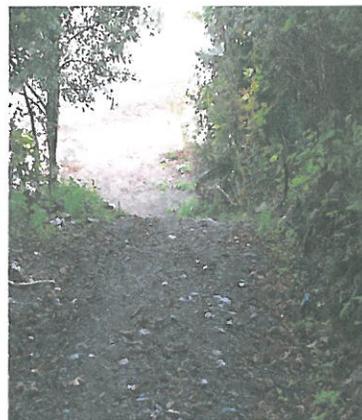
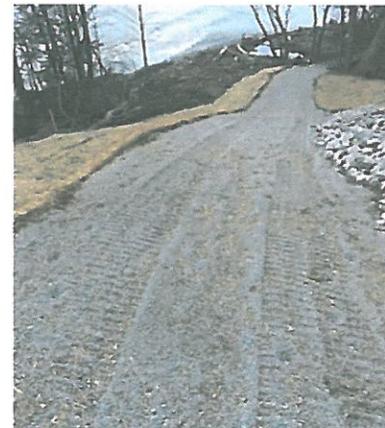
After

The outcome of this project is significant. A much wider, traversable trail with no dangerous erosion areas to maneuver around. Persons young and old can now walk this trail to the water's edge without the fear of sliding down the steep slopes. While the trail still has a downward slope, the trek up and down is much more manageable and the walking surface is secure. The width of the trail allows more than one person to walk next to each other and will allow a gator and a rescue basket to be taken down it safely to help those in water despair or other health related issues so that they can be extricated safely. A gate will go across the entrance to the trail at the top to eliminate unwanted vehicle traffic. Only emergency personnel, law enforcement and the Township will have access to the gate for motorized vehicles. This trail will allow fishermen, nature lovers, kayakers, canoers, hikers and the like to safely recreate in this beautiful area of Lake Erie Community Park.
